Debris/Ice/TPS Assessment and Integrated Photographic Analysis of Shuttle mission STS-112

**DEBRIS/ICE/TPS ASSESSMENT and
INTEGRATED PHOTOGRAPHIC ANALYSIS
OF SHUTTLE MISSION STS-112**

Armando Oliu
Process Engineering/Mechanical System Division/ET-SRB Branch,
Kennedy Space Center, Florida

October 7, 2002

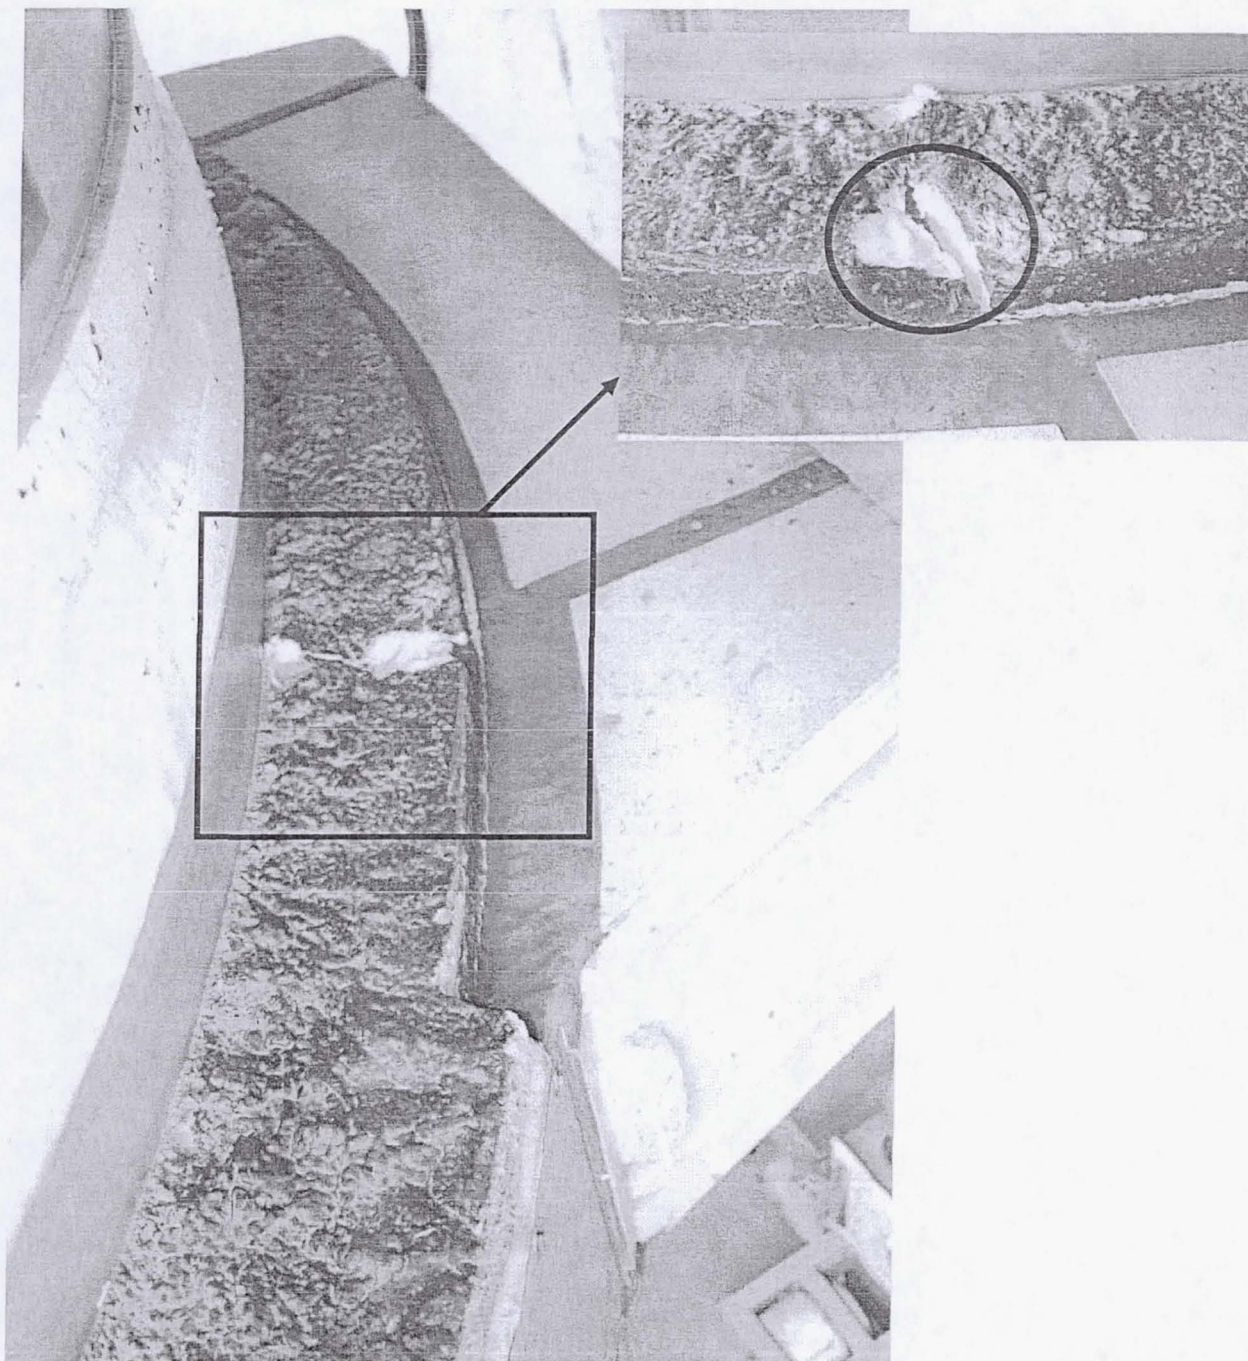
Photo 11: LH SRB Post Flight Condition

Evidence of a debris impact on the ETA ring of the near the IEA box. The impact site is approximately 4 inches in diameter and 3 inches in depth.

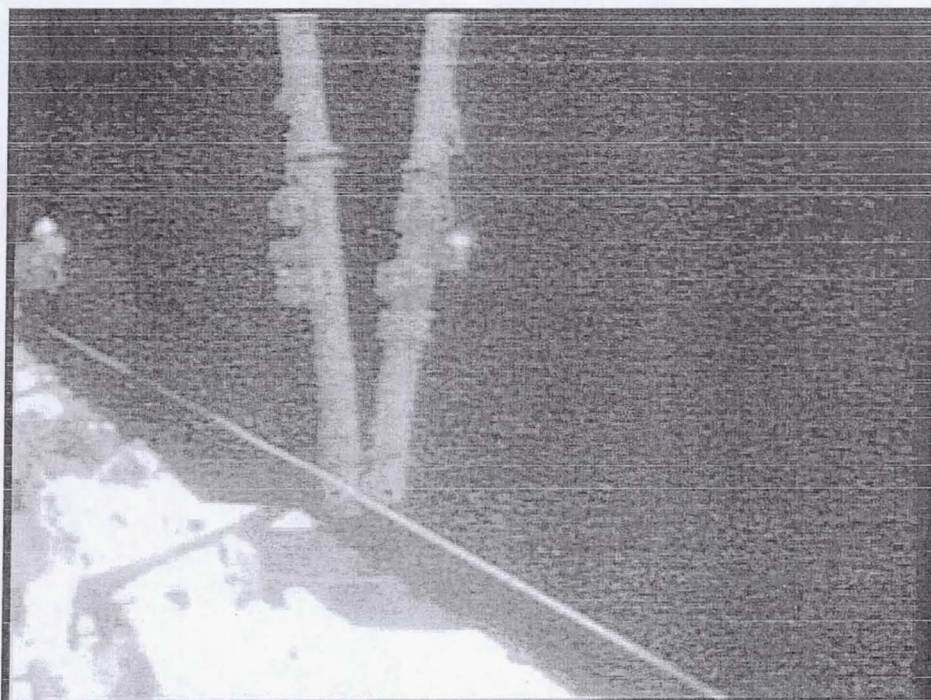
Figure 1.1.2 View of SSRMS in the “near-miss” with the Payload Bay Door

At the request of the MER, video was reviewed of the "near miss" of the station RMS arm with the Orbiter payload bay door during the first EVA. The one available view was not adequate to allow a measurement to be made of how close the arm came to the payload bay door. See Figure 1.1.2.

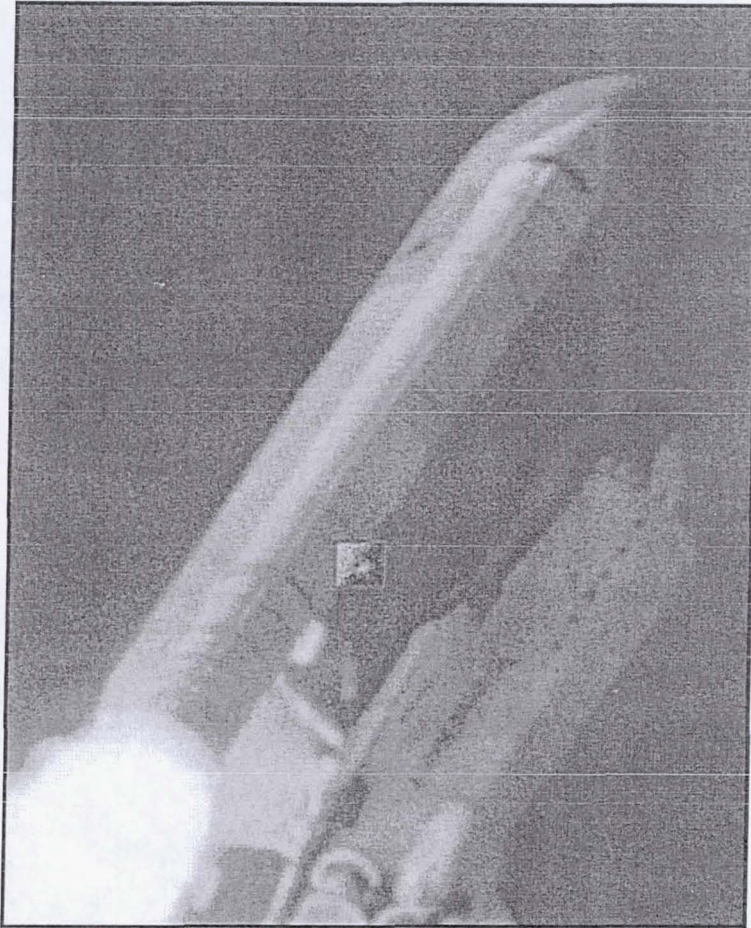
Figure 2.1 (A) Debris Seen Prior to IEA Box Impact (Camera E222)

A single piece of light-colored debris was seen to impact the ETA ring near the IEA box on the LSRB at approximately 33 seconds MET (19:46:24.690 UTC). After impact the debris broke into multiple pieces and fell aft along the LSRB exhaust plume. On Camera E207, a large spray of debris was seen falling aft along the LSRB aft skirt that was probably from this event (19:46:24.727 UTC). The debris was first visible aft of the ET intertank near the ET hydrogen tank TPS (19:46:24.590 UTC), one tenth of a second prior to the debris impact with the ETA ring. The source of this debris may be the missing TPS seen on the ER ramp near the -Y foot of the ET/Orbiter forward bipod attach. See Section 2.4.1. (Cameras E212, E220, E222)

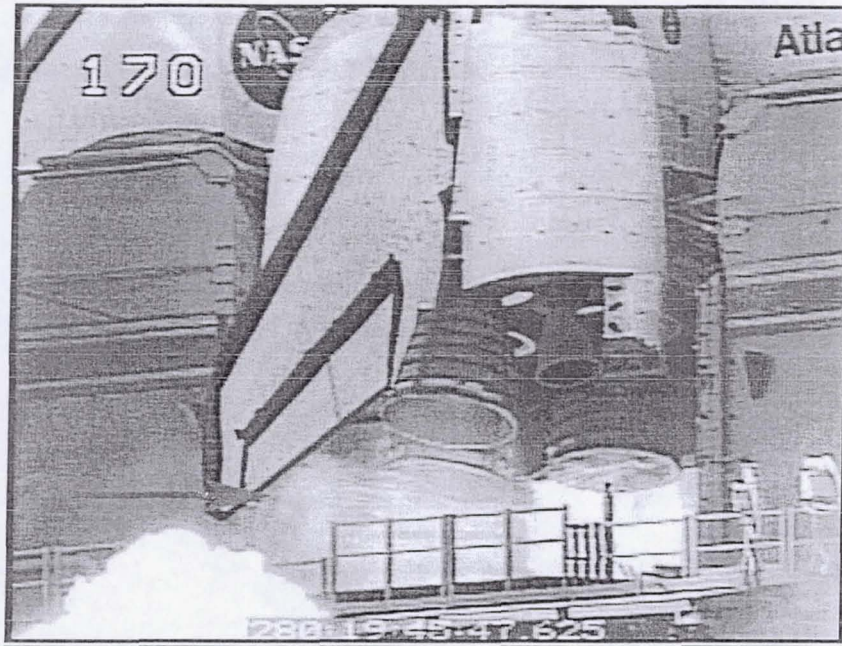
Figure 2.1 (B) Orange Puff Seen Near Vertical Stabilizer During SSME Start-up

During SSME start-up, a large, orange-colored puff was seen near the trailing edge of the vertical stabilizer during SSME ignition (19:45:47.625 UTC) approximately 0.5 seconds prior to the SSME #1 Mach diamond formation. (On STS-111 a similar orange flash was seen at approximately 1.2 seconds prior to the SSME #1 Mach diamond formation.)

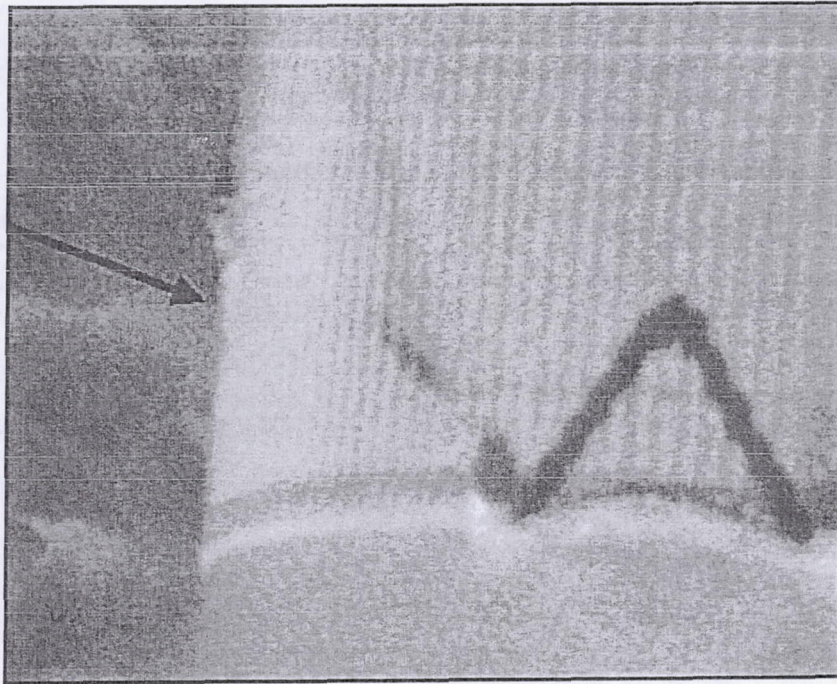
Figure 2.1 (C) Missing Foam Material on -Y Thrust Panel. Image Courtesy of Marshall Space Flight Center (Camera FL102)

On the umbilical well camera films, missing foam material was seen on the -Y Thrust Panel in the +Z direction from the EB Fitting. See Figure 2.1 (C). The missing foam material could be the possible cause of the damage found post-landing on the left side of the Orbiter lower fuselage tiles. Similar patterns of missing foam were seen on STS-99.

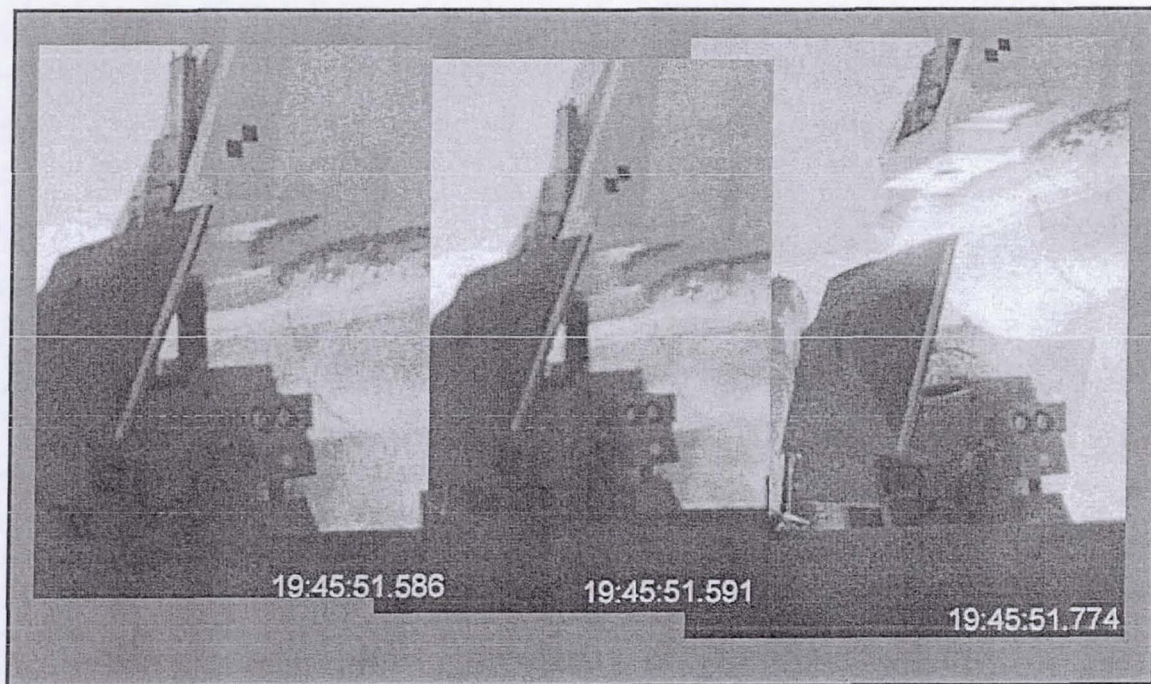
Figure 2.3.2 (A) Image Sequence of Holddown Post M-3 Bolt Hang-up (Camera E10)

The RSRB holddown post M-3 bolt was seen to hang-up during liftoff. The bolt appeared to be fully extended and was estimated to be ten to eleven inches above the plane of the holddown post shoe at the time of release. See Figure 2.3.2 (A). Table 2.3.2 (A) contains a timeline of the holddown post M-3 bolt hang-up events. (Camera E10)

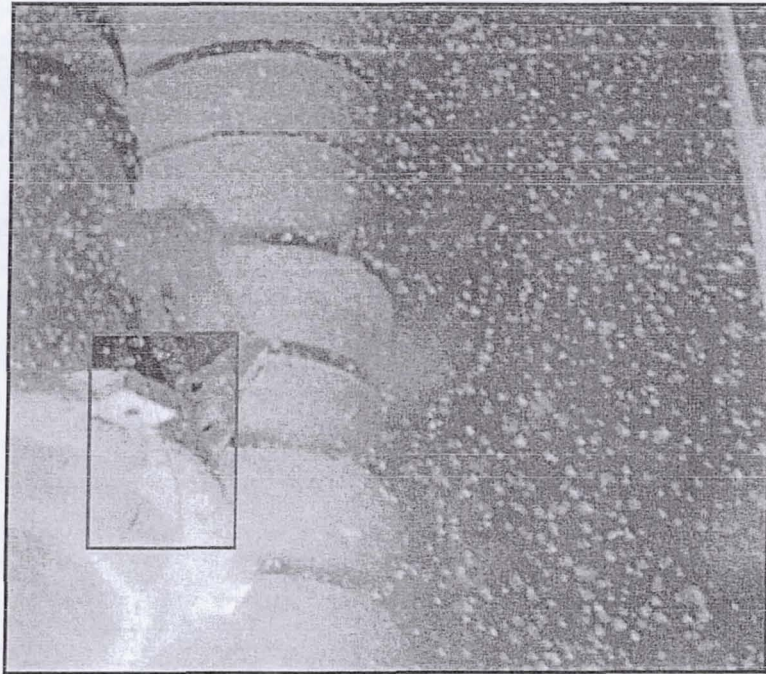
Figure 2.3.2 (B) (Camera E31)

A PIC wire did not release but was seen to remain attached to LSRB aft skirt at the post M-6 DCS during liftoff (19:45:53.0 UTC). See Figure 2.3.2 (B) (Cameras E13, E31, E34)

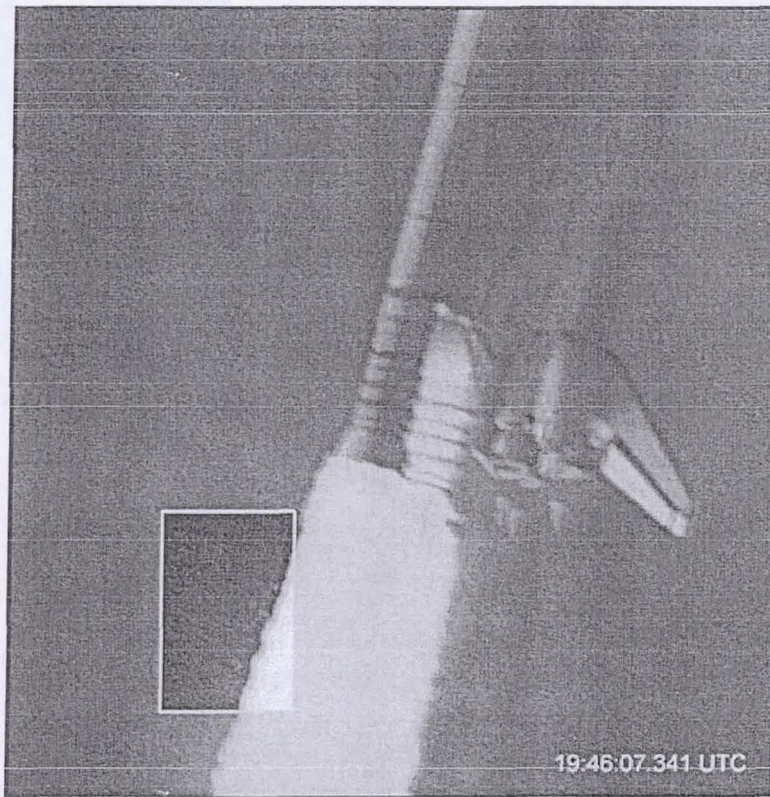
Figure 2.4.2 (A) Spray of Debris Exiting the LSRB Exhaust Plume (Camera E52, E222)

Numerous pieces of debris (in excess of twenty) were seen falling aft from the LSRB exhaust plume near the LSRB aft skirt during early ascent (19:46:07.341 UTC). See Figure 2.4.2 (A). Although debris exiting the SRB exhaust plumes has been typically seen on previous

mission imagery, this event is considered unusual because of the amount (not size) of debris that was visible. (Camera E52, E222)

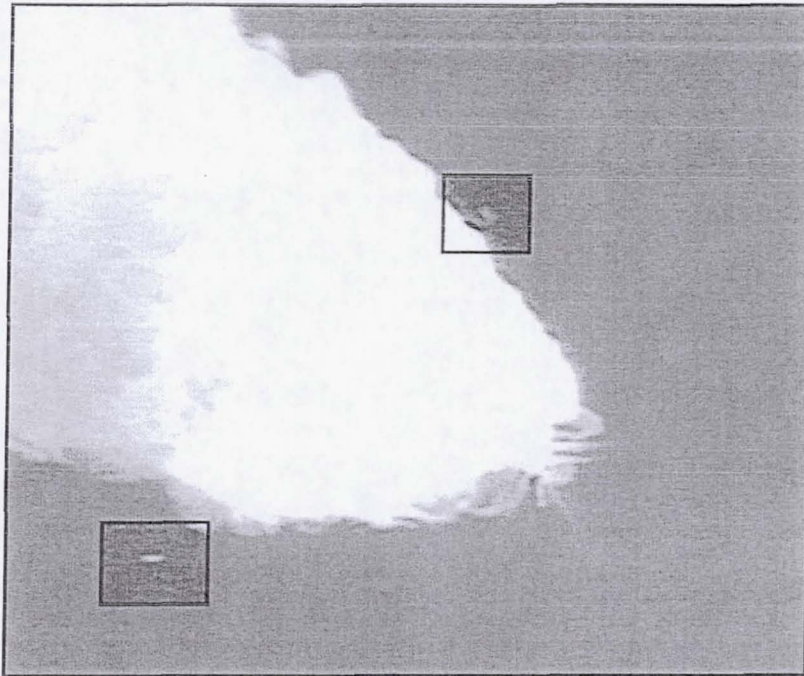
Figure 2.4.2 (B) Debris Exiting the SRB Exhaust Plume During Ascent (Camera KTV4B)

As on previous missions, light-colored debris was seen exiting the SRB exhaust plumes during ascent. The debris exiting the SRB exhaust plumes during late ascent was probably instafoam from the aft end of the SRBs. See Figure 2.4.2 (B). The more dense appearing debris near the time of tail-off, just prior to SRB separation, was probably SRB slag debris. Examples of this debris are provided in Table 2.4.2.

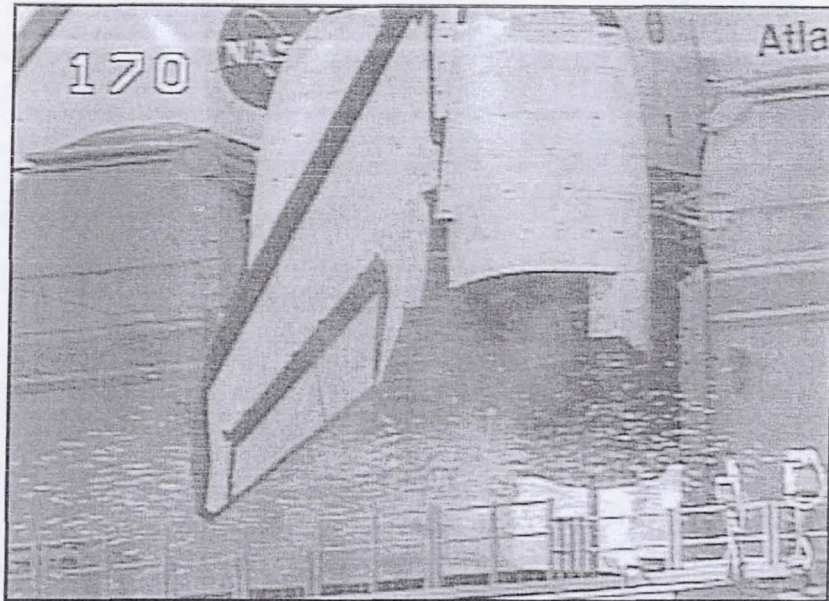
Figure 2.4.3 Orange Vapor Seen Forward of SSME Rims (Camera OTV170)

Orange vapor (possibly free burning hydrogen) was seen forward of the SSME rims, near the drag chute door, forward of the trailing edge of the vertical stabilizer, and near the base heat shield during SSME ignition. See Figure 2.4.3. A large, orange-colored flash was seen near the trailing edge of the vertical stabilizer during SSME ignition (19:45:47.617 UTC) approximately 0.5 seconds prior to the SSME #1 Mach diamond formation. (On STS-111 a similar orange flash was seen at approximately 1.2 seconds prior to the SSME #1 Mach diamond formation.) Orange vapor forward of the SSME rims during SSME ignition has been seen on previous mission films and videos. (Cameras OTV170, KTV4B, ET213, E2, E17, E18, E19, E20, E52, E63, E222)

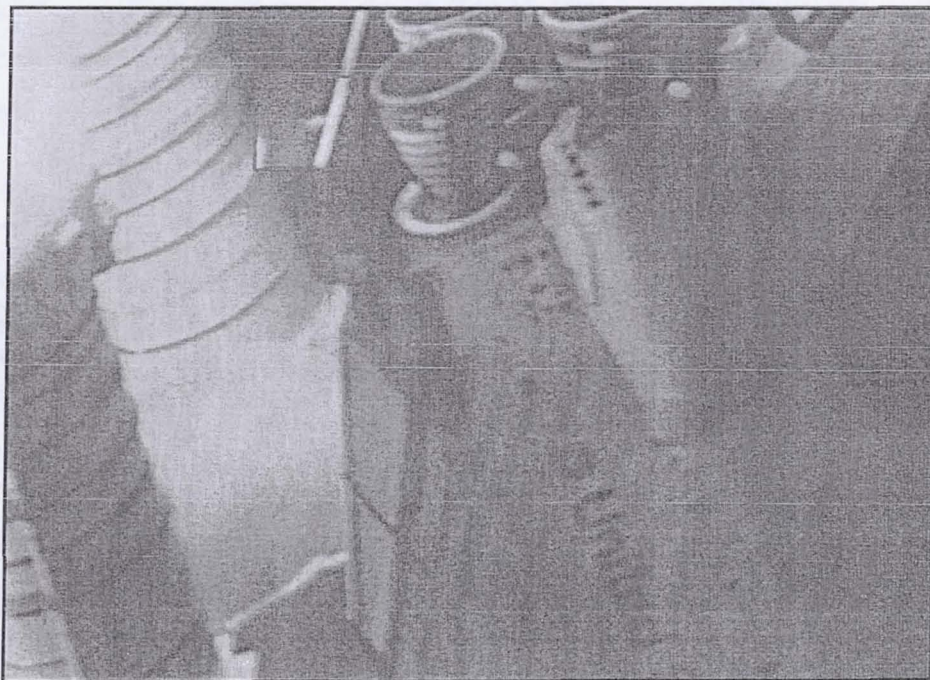
Figure 2.4.4 (A) Umbilical Purge Barrier Material Seen Aft of Body Flap (Camera E207)

Pieces of ET umbilical well purge barrier material were seen along the -Z side of the body flap, aft of the ET aft dome, and between the two SRBs during ascent (19:46:01.686, 19:46:06.686, 19:46:08.025, 19:46:09.6, 19:46:12.086, 19:46:15.183, 19:46:15.561, 19:46:21.364, 19:46:30.717 UTC). See Figure 2.4.4 (A). Umbilical purge barrier material falling from the ET umbilicals has been typically seen on the previous mission tracking camera views. (Cameras ET207, E52, E54, E207, E222)

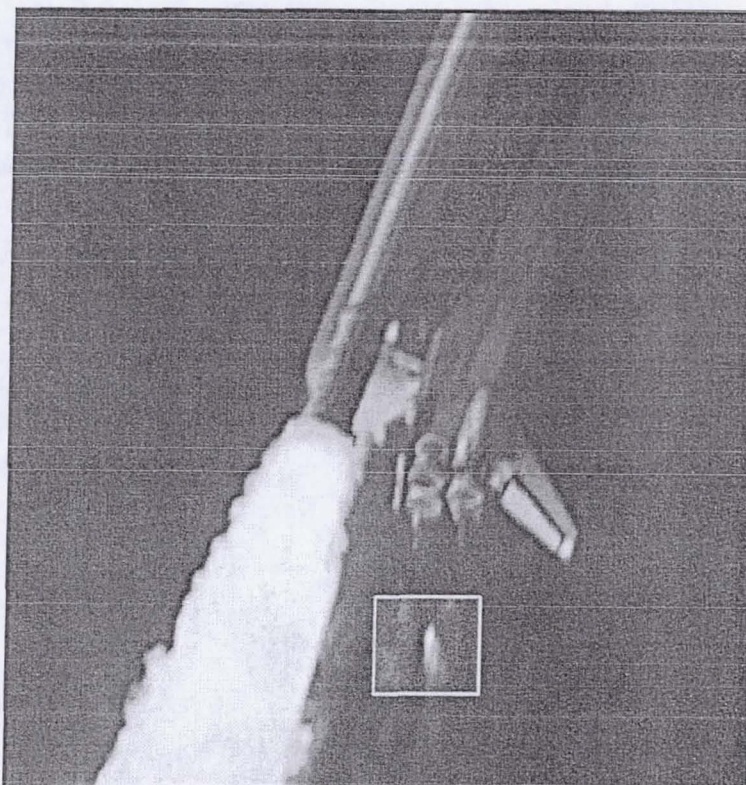
Figure 2.4.4 (B) Flare Seen in SSME Exhaust Plume (Camera E222)

Light-colored flares (possibly debris induced) were seen in the SSME exhaust plumes during ascent on the intermediate and long range tracking camera films and videos. See Figure 2.4.4 (B). (Often on previous mission imagery, debris has been seen contacting the SSME exhaust plume resulting in visible flares. Usually this debris was RCS paper. On STS-26 and STS-101, debris that resulted in very large orange-colored flares was determined to have been tile material.) Examples of flares seen on STS-112 can be seen in Table 2.4.4. Flares in the SSME exhaust plumes have been seen on previous missions films and videos.

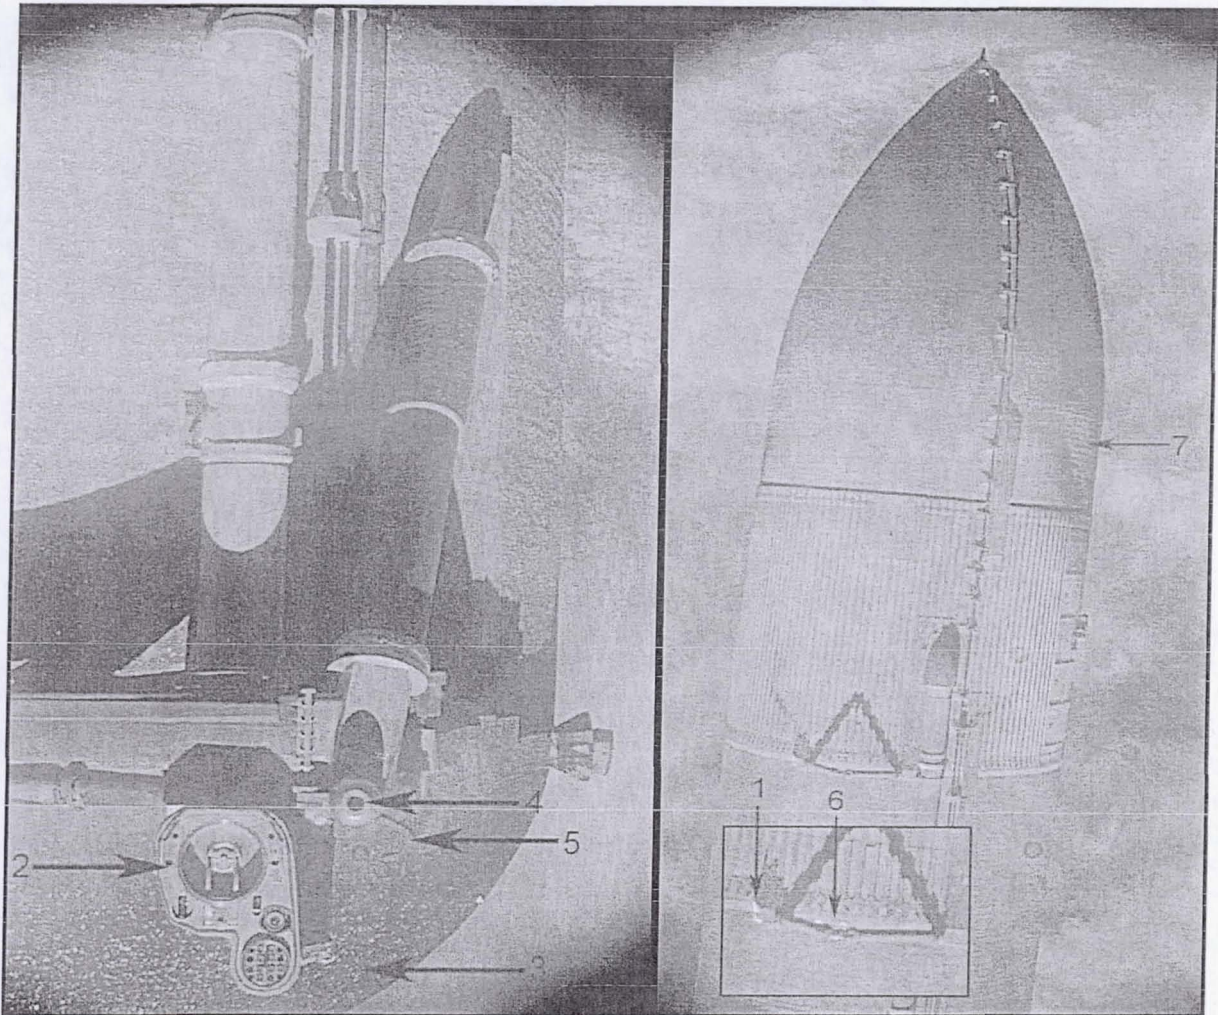
Figure 2.5.1 35mm Images of the ET during Separation (Frames 8 and 30)

A large portion of the ramp adjacent to the -Y foot of the ET / Orbiter forward bipod attach is missing. See Figure 2.5.1, annotation 1. The damaged area measured approximately 6 x 12 inches. Substrate material is visible. This is considered to be a possible source for the debris that was seen striking the LSRB ETA ring on the launch camera films.

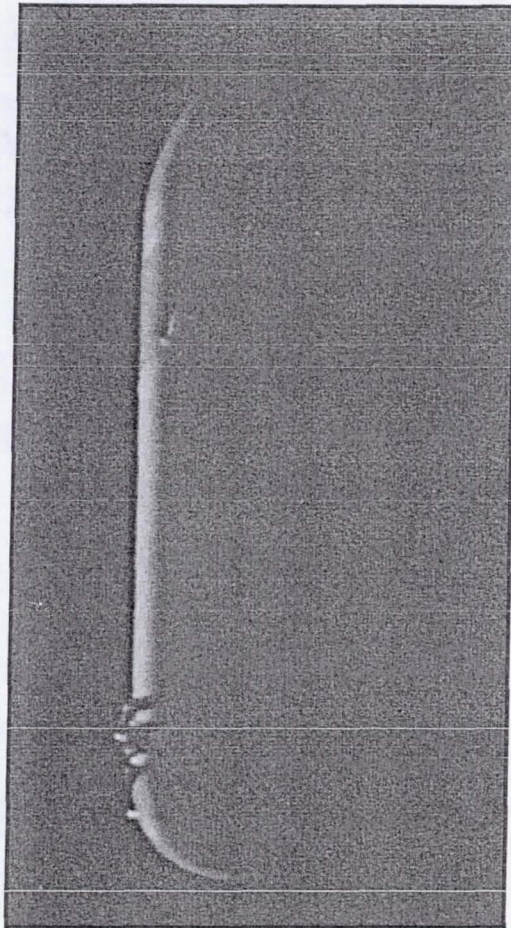
Figure 2.5.3 Handheld Image of the External Tank (Frame 6)

No anomalous or unusual observations were noted on the handheld film views. The ET was almost 100% back-lighted by the late afternoon Sun. Therefore, analysis of the film was not possible because of the extensive shadows on the ET. See Figure 2.5.3.

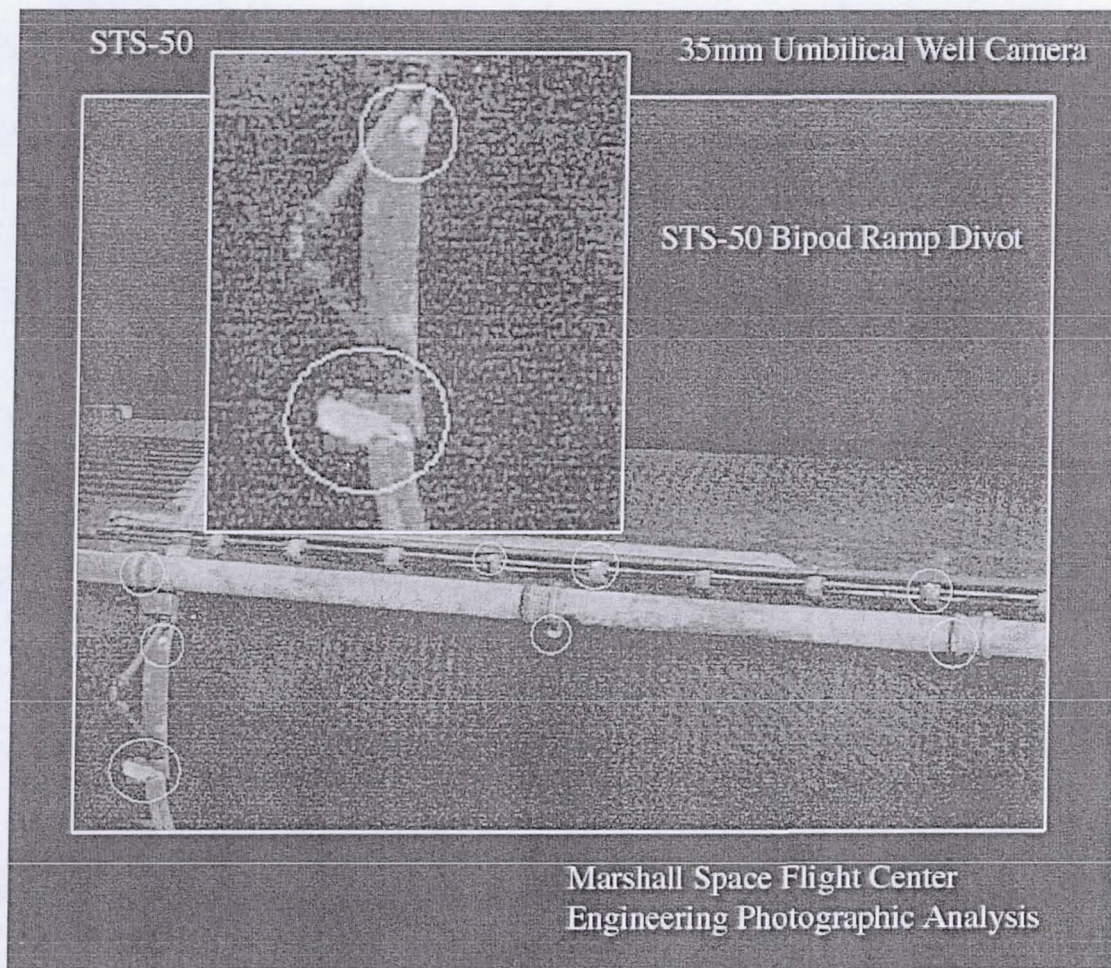
Figure 2. UMB035MM: Bipod Ramp Divot on STS-50

Illustration of an External Tank TPS divot reported on STS-50 that is similar to the divot noted on STS-112.

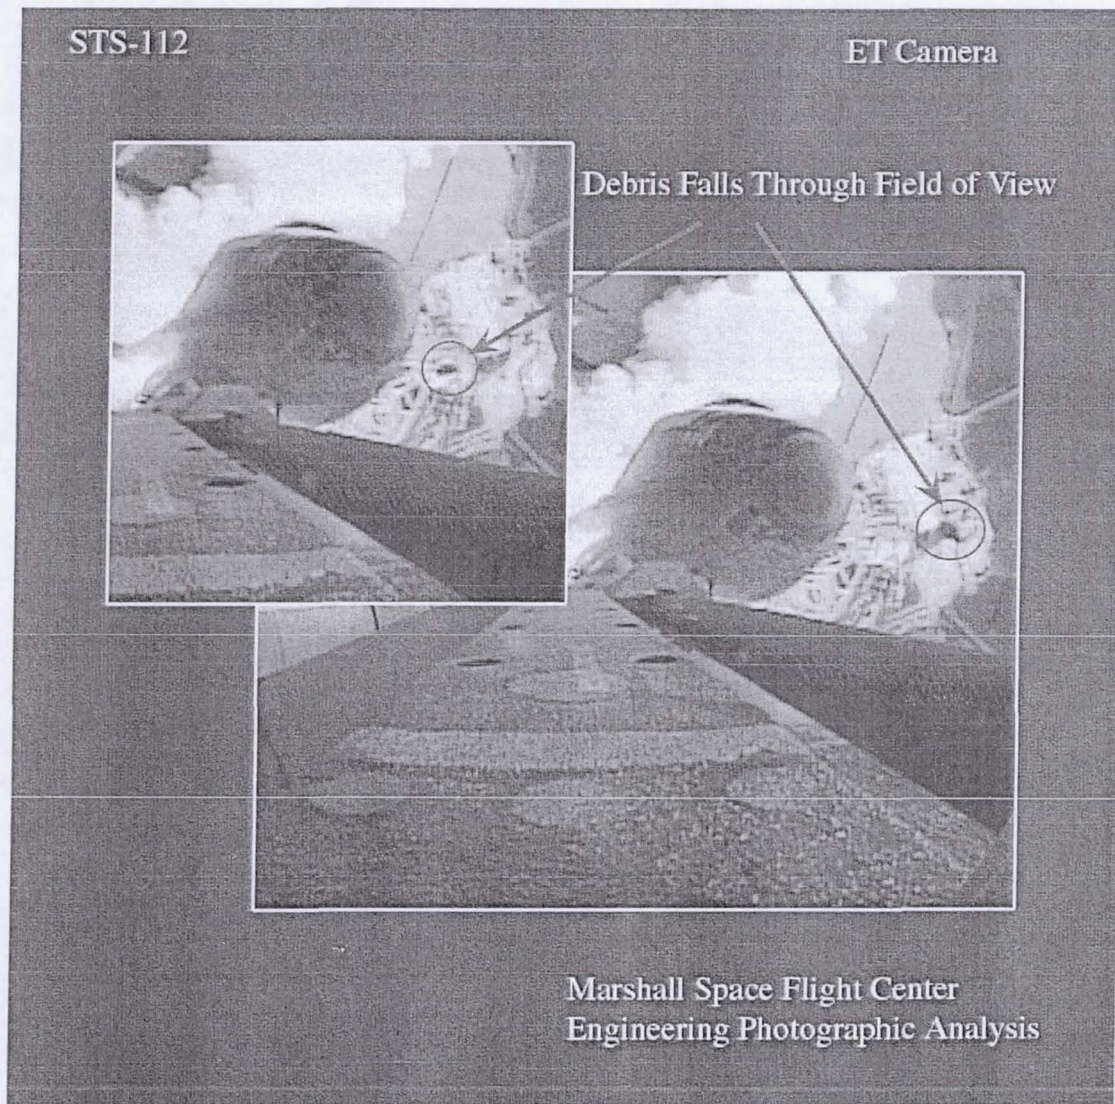
Figure 9. ETCAM: Debris Falling Aft from Forward of Camera

Several debris items were noted just after liftoff. These debris items were falling aft from forward of the camera.

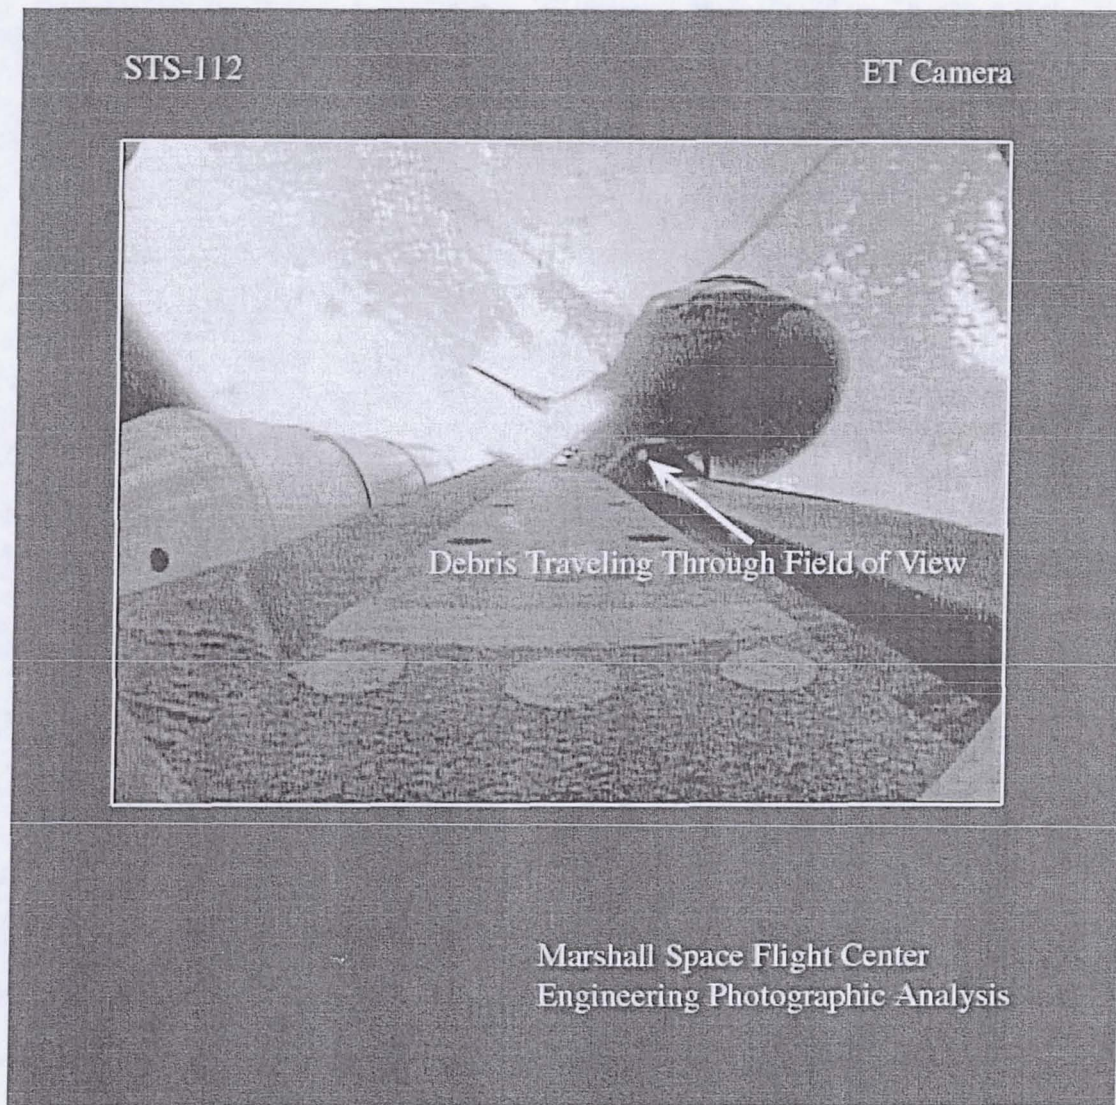
Figure 10. ETCAM: Debris Falling Aft

Debris was observed falling aft of the vehicle during ascent.

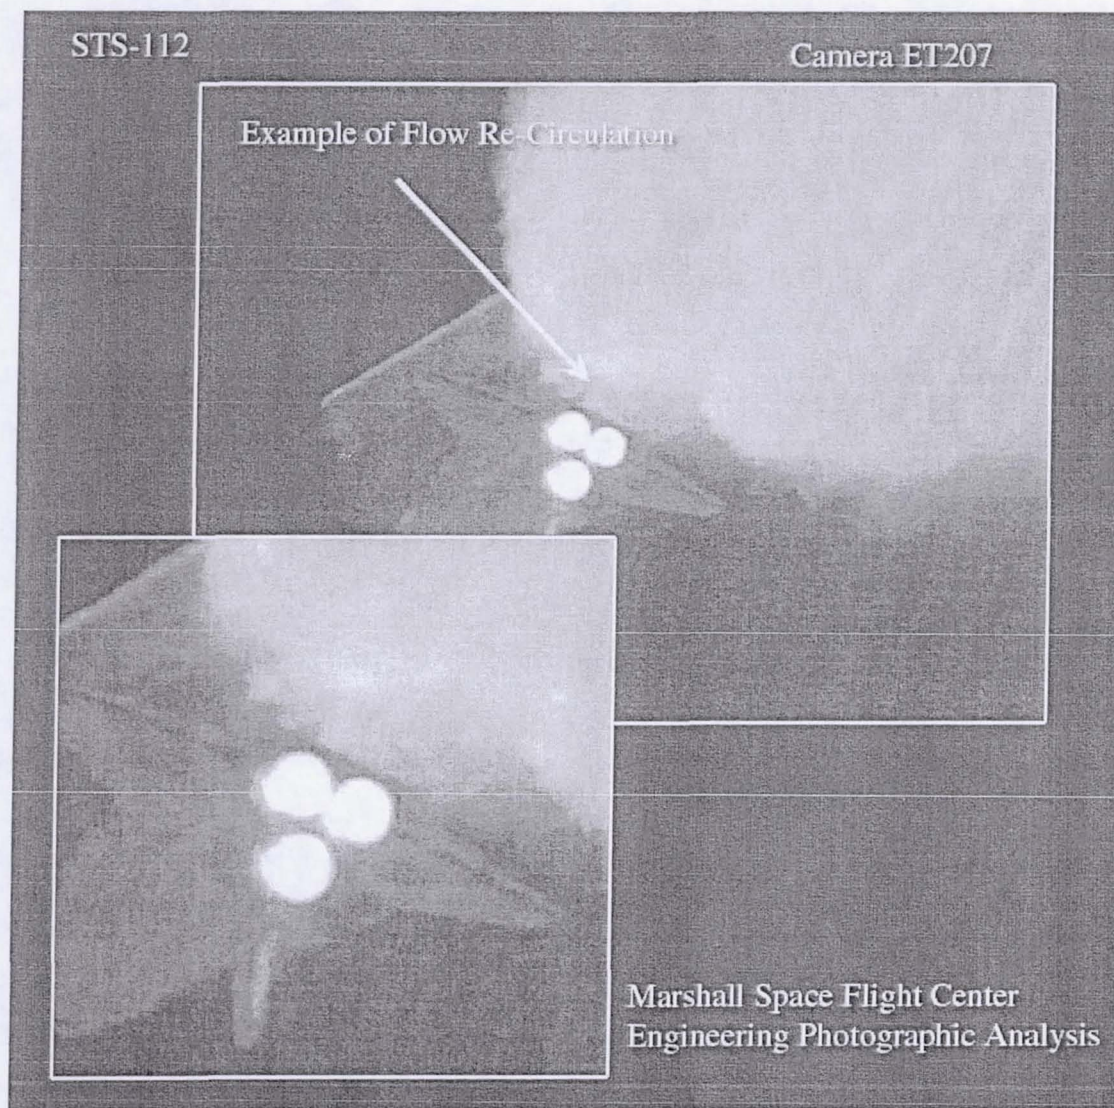
Figure 11. ET207: Flow Recirculation

Glow from hot recirculating combustion gases near the aft dome, "Flow Recirculation", was observed on this mission. This is a typical and expected observation.

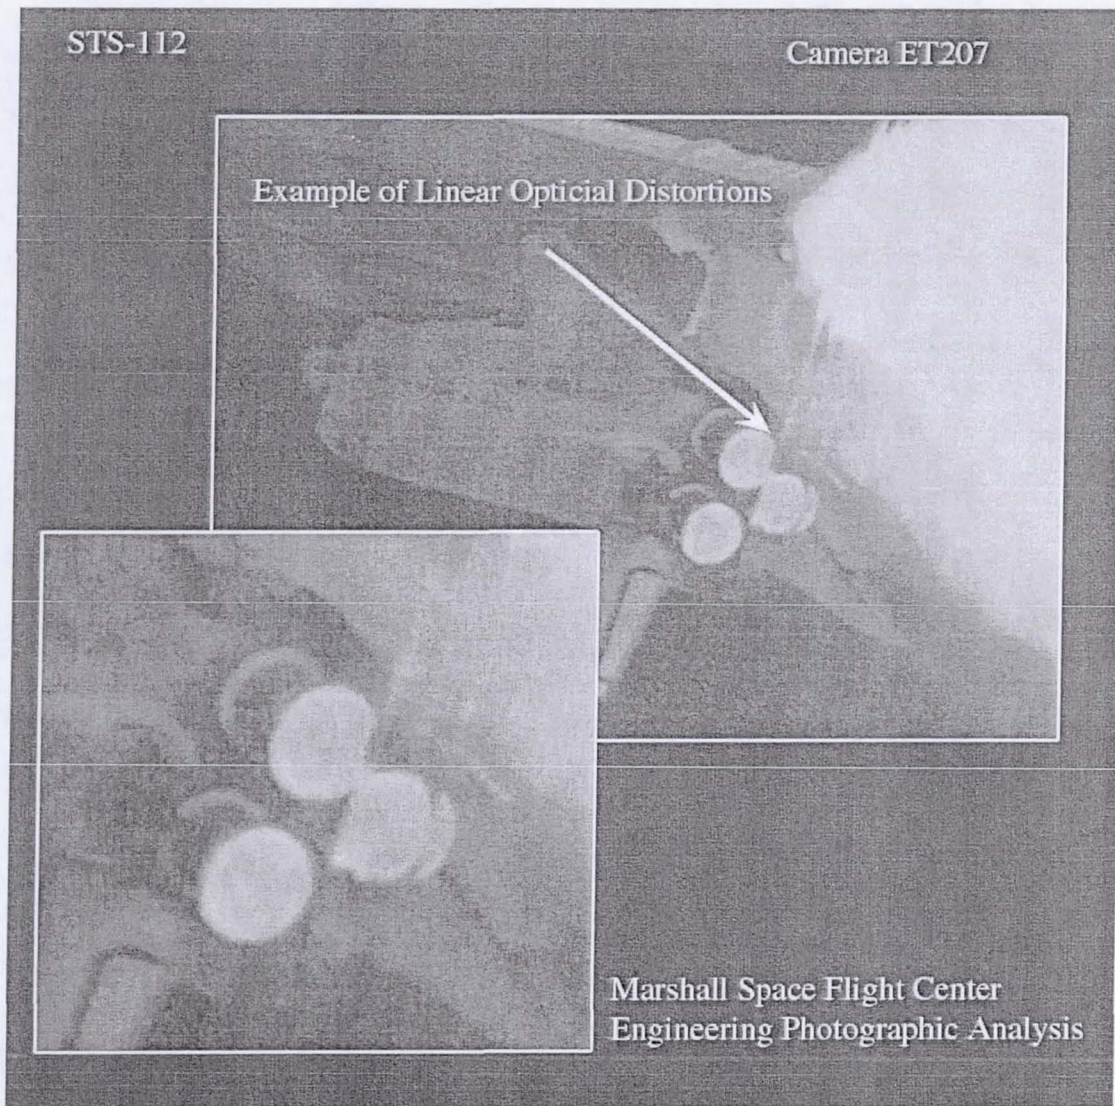
Figure 12. ET207: Linear Optical Distortion

Several Linear Optical Distortions were observed during this mission. Linear Optical Distortions are a common observation.

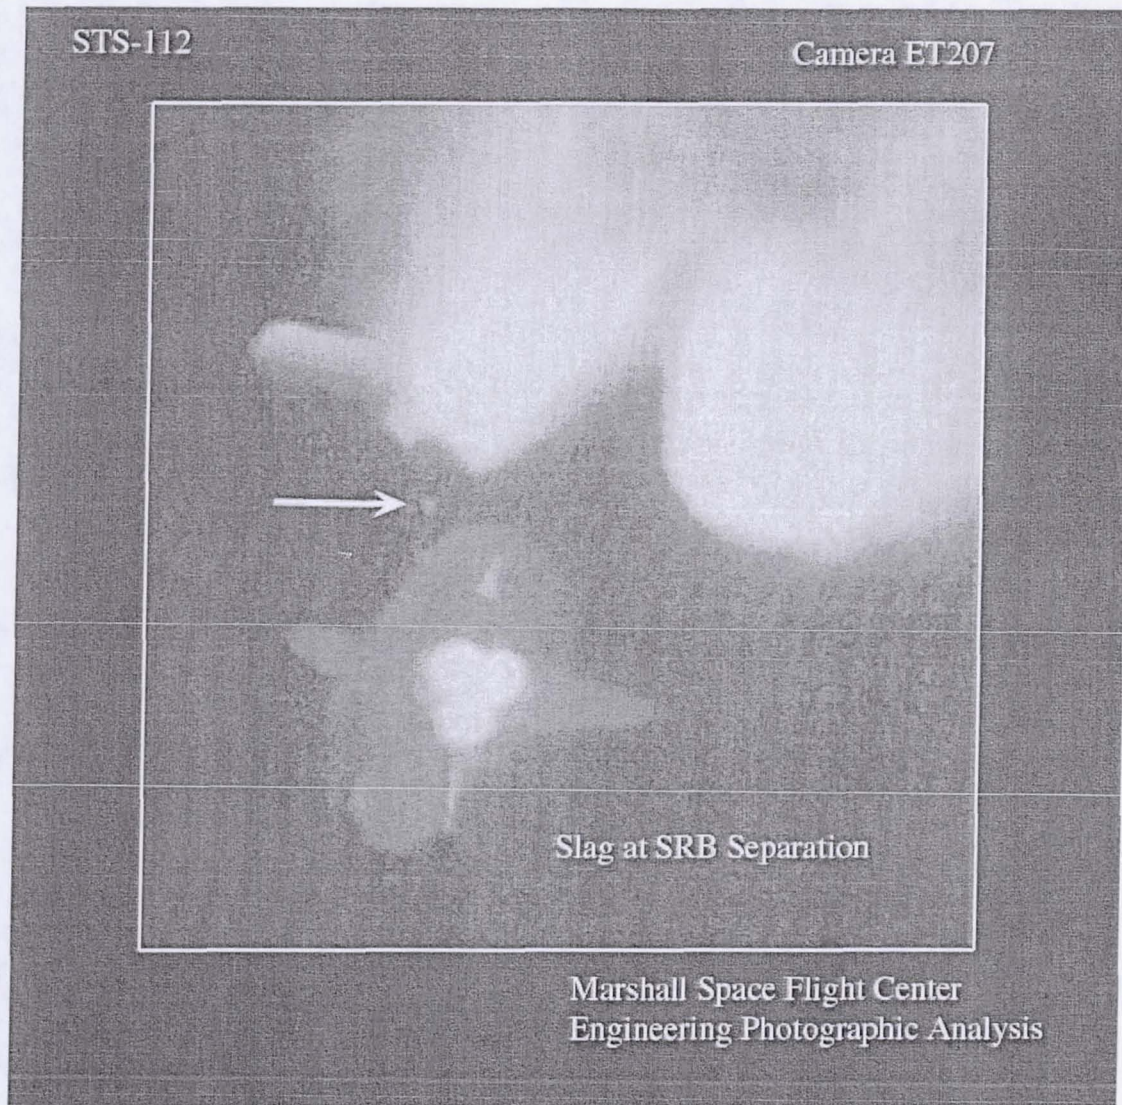
Figure 13. ET207: Slag Ejected from SRB Plumes at SRB Separation

Glowing debris particles, probably SRB slag, was ejected from the SRB plumes at SRB separation. This is a typical observation.

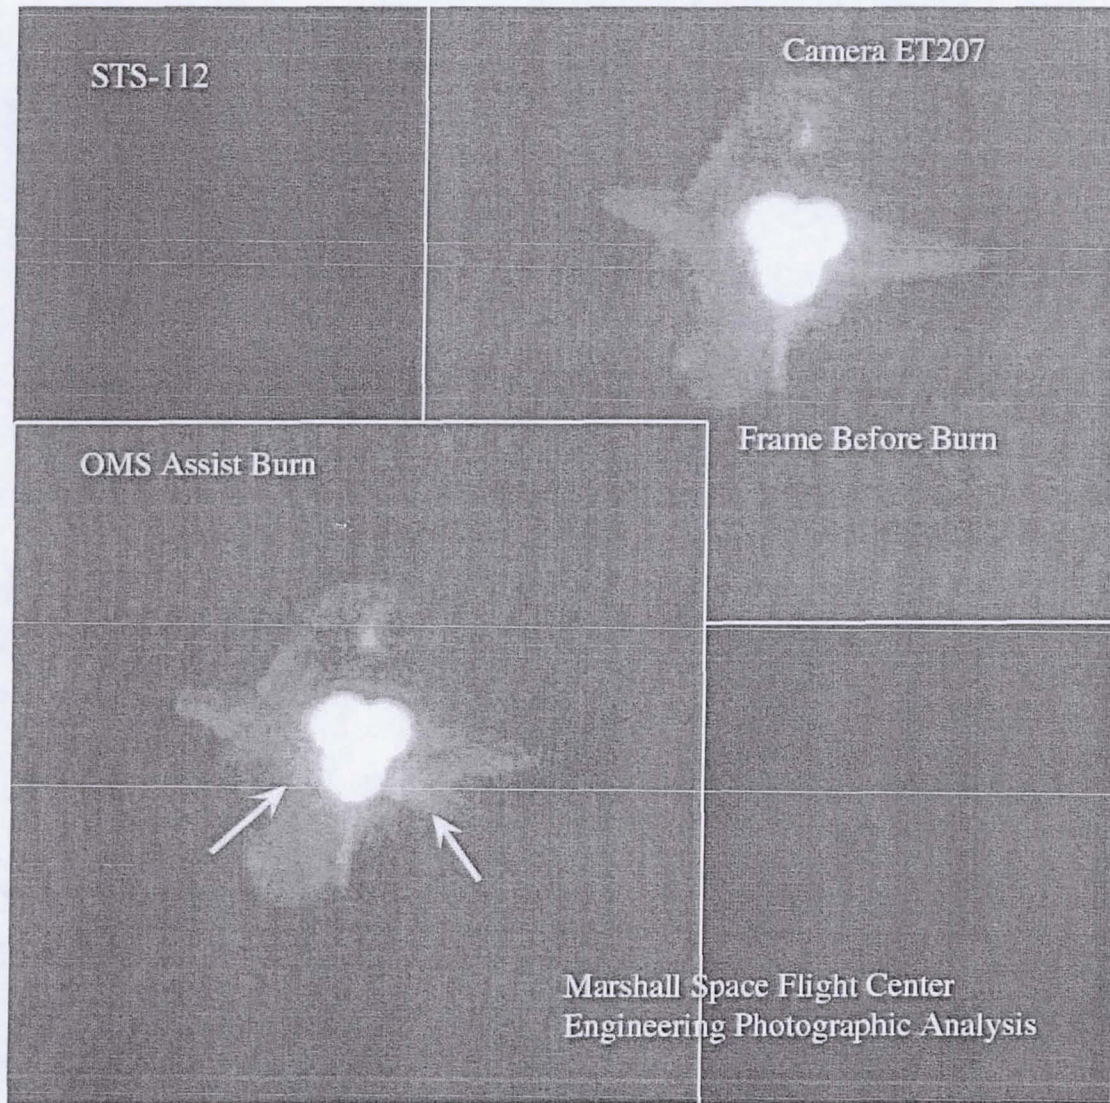
Figure 14. ET207: OMS Burn after SRB Separation

ET207: OMS Burn after SRB Separation

The slightly orange colored streak noted near the SSME exhaust is indicative of the OMS Assist burn. This is a typical observation for this event.

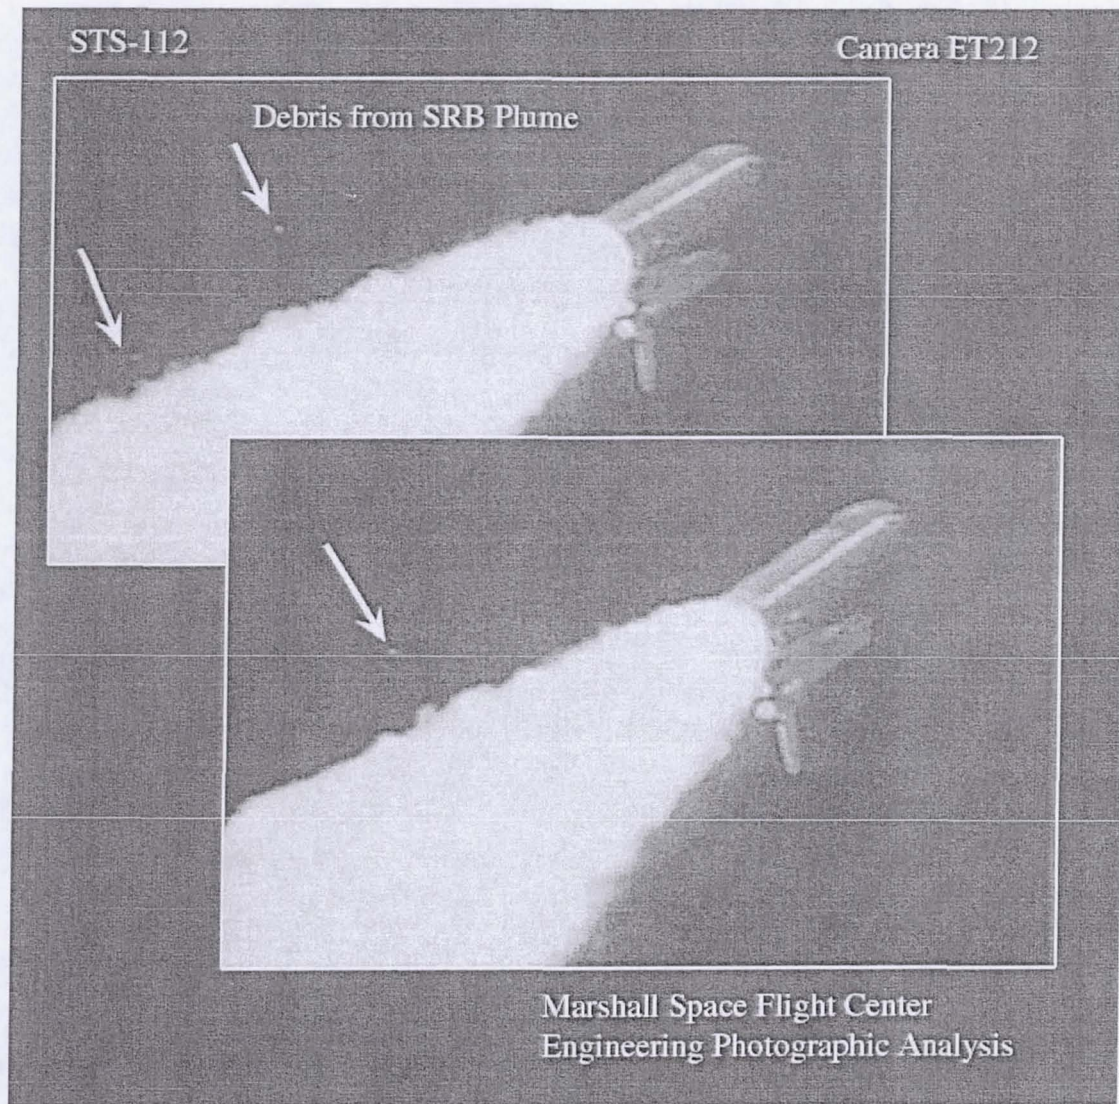
Figure 15. ET212: Debris Ejected from SRB Plumes Prior to SRB Separation

ET212: Debris Ejected from SRB Plumes Prior to SRB Separation

Debris was ejected from the SRB plumes during ascent.
